# **Reliability of CGA/LGA/HDI Package Board/Assembly (Final Report)**

Reza Ghaffarian, Ph.D.  
Jet Propulsion Laboratory  
Pasadena, California

JPL Publication 14-14 9/14

NASA Electronic Parts and Packaging (NEPP) Program  
Office of Safety and Mission Assurance

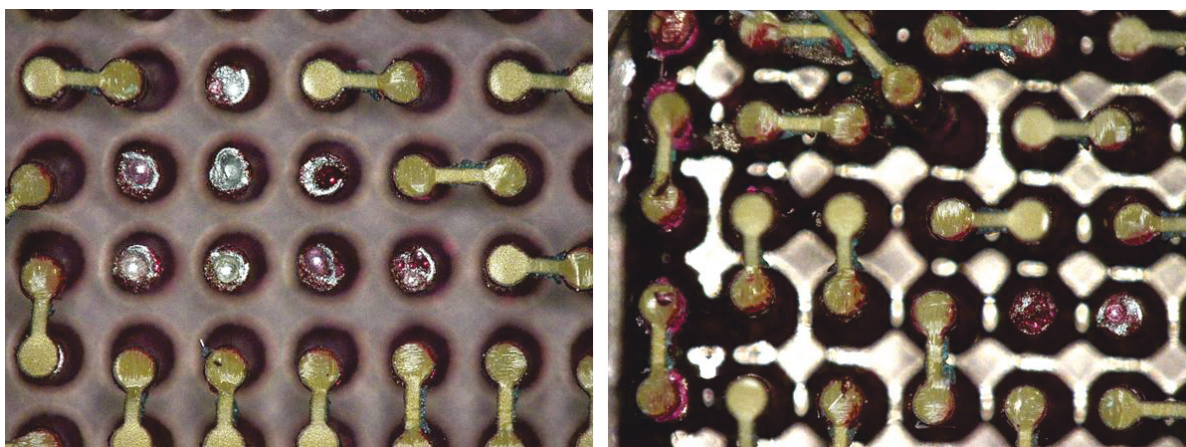
**Figure 4-10.** Representative dye-and-pry photomicrographs of failures at the package site for CGA1272 with the ink defect and smaller PCB pad sizes after cycling ( $-55^{\circ}/125^{\circ}\text{C}$ ).

After failure of this assembly, the dye-and-pry technique was used to verify failure mechanism due to the ink defect and smaller pad size. Figure 4-9 shows photomicrographs of the PCB pad pattern after full separation due to prying. Photomicrographs of the four corners and an enlarged pattern pads are included in the photos. As expected, stain covered corner pads indicate a failure condition from the PCB pads. This however, was not the case for the most of the other pads, even though copper pad separation from the PCB was dominant. The package pad sites showed a lower number of separations (see Figure 4-10). The white reflections at the separated package represent pad separation during thermal cycling. The failures from either package or PCB sites clearly show competing failure mechanisms; in which for this case, failure becomes dominant at the PCB sites. The ink defect and smaller pad sizes favored failure at the PCB sites.

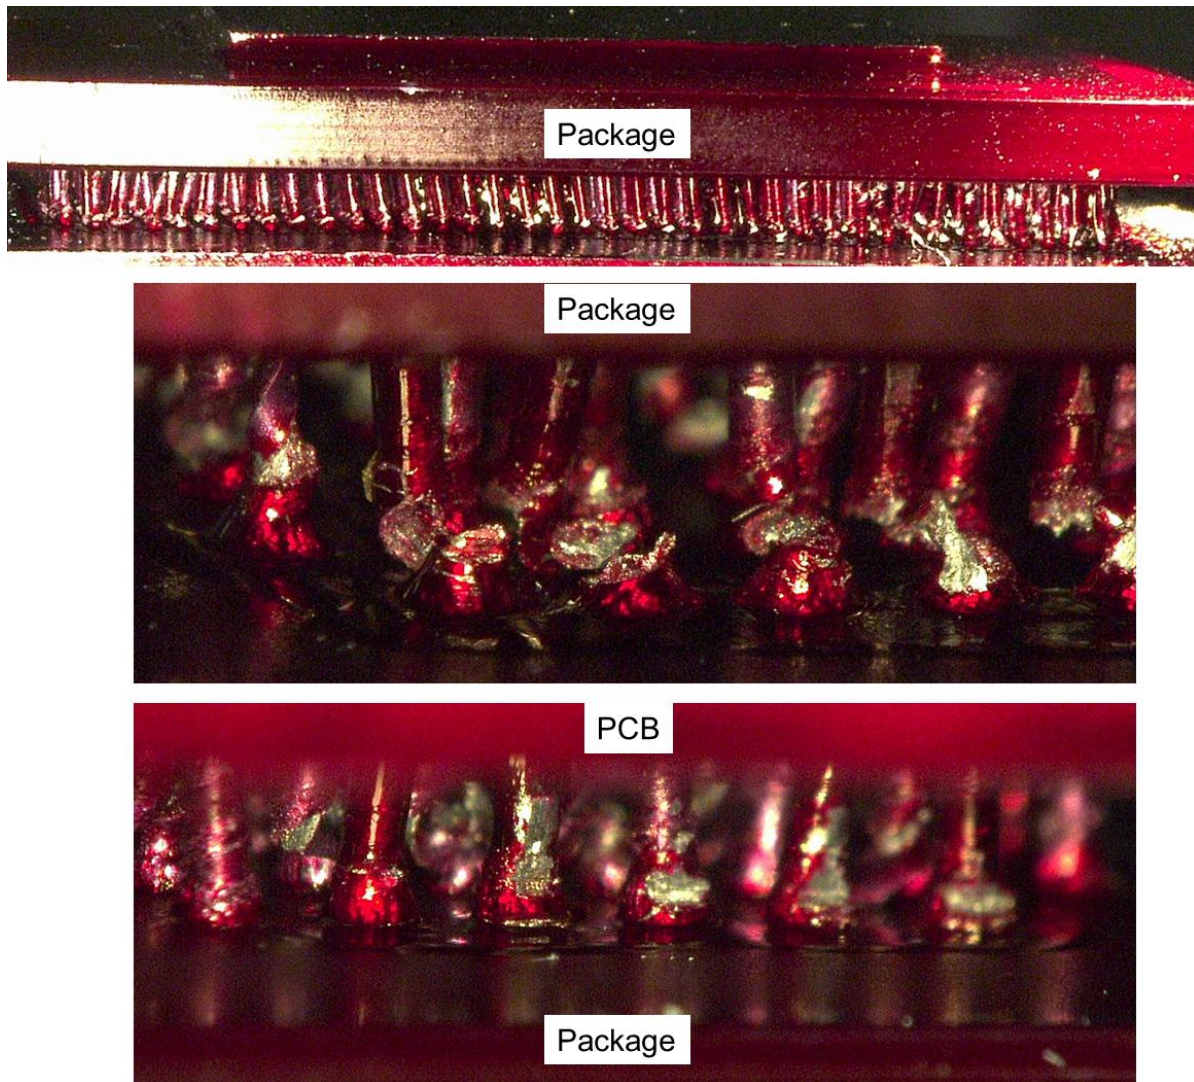
**Figure 4-11.** Representative dye-and-pry photomicrographs of failures at PCB site for CGA1517 after cycling ( $-55^{\circ}/125^{\circ}\text{C}$ ).

The CGA1517 on TV5 (SN016) had no daisy-chain pattern. After completion of a number of thermal cycles ( $-55^{\circ}$  to  $125^{\circ}\text{C}$ ), an assembled package was cut in halves, and one section was subjected to red dye first and pried for failure analysis. Figure 4-11 shows photomicrographs of the assembly after the half

sample was subjected to prying, but in this case, it was not fully separated. The top photo shows an overall image of package stained showing lack of full separation. Column distortion with copper wrap twist or failure is apparent. The middle photo is a higher magnification of the top photo with focus on the failure modes at the PCB interfaces. It shows no apparent failure of the solder joints yet. The bottom photo concentrates on the package solder joint interface failure. Again, there are no apparent failures of solder joints at the interfaces.

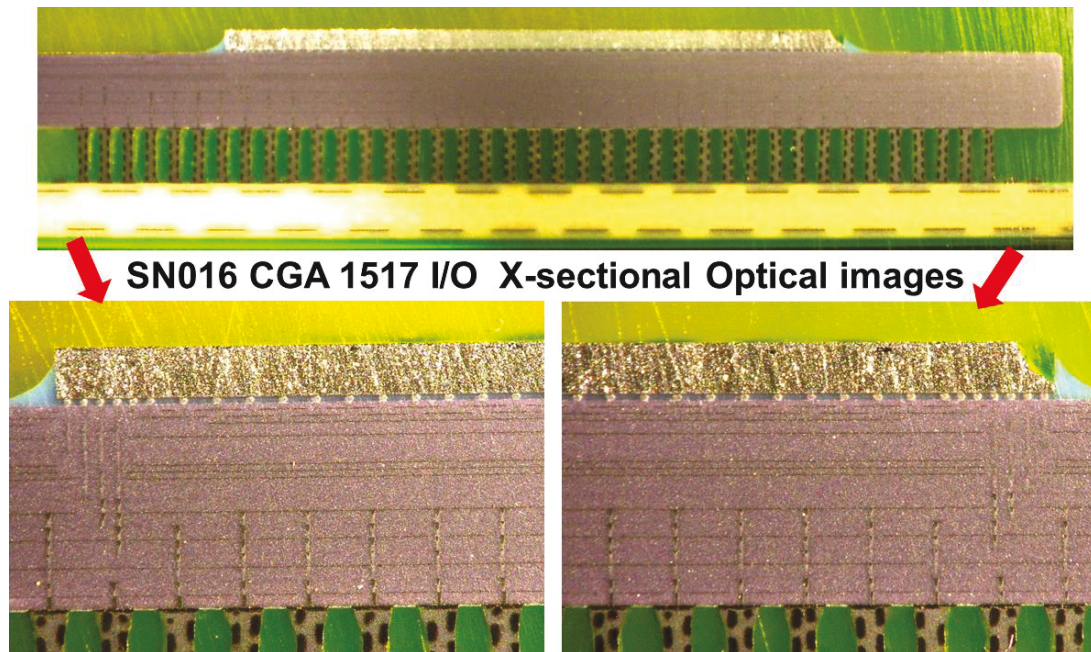
**Figure 4-12.** Representative optical cross-sectional photomicrographs of CGA1517 showing minimum signs of damage for the flip-chip solder joints within package after cycling ( $-55^{\circ}/125^{\circ}\text{C}$ ).

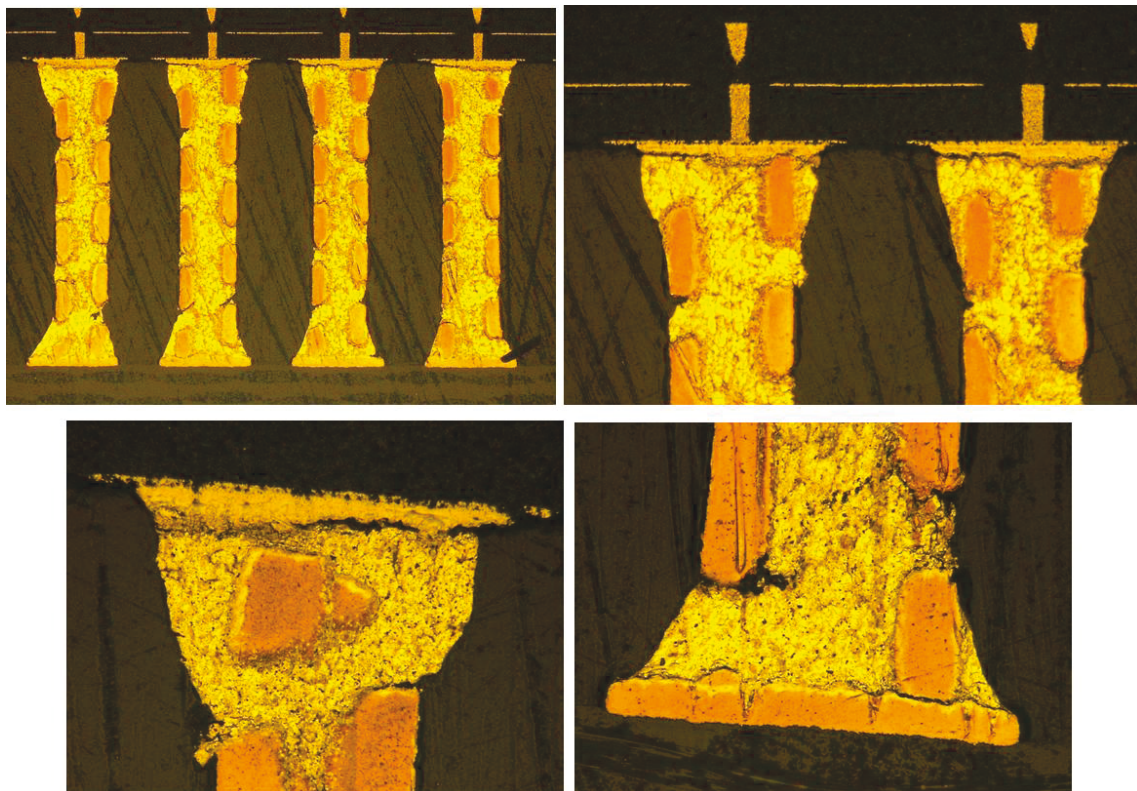
**Figure 4-13.** Representative cross-sectional optical photomicrographs of CGA1517 showing microcracking after cycling ( $-55^{\circ}/125^{\circ}\text{C}$ ).

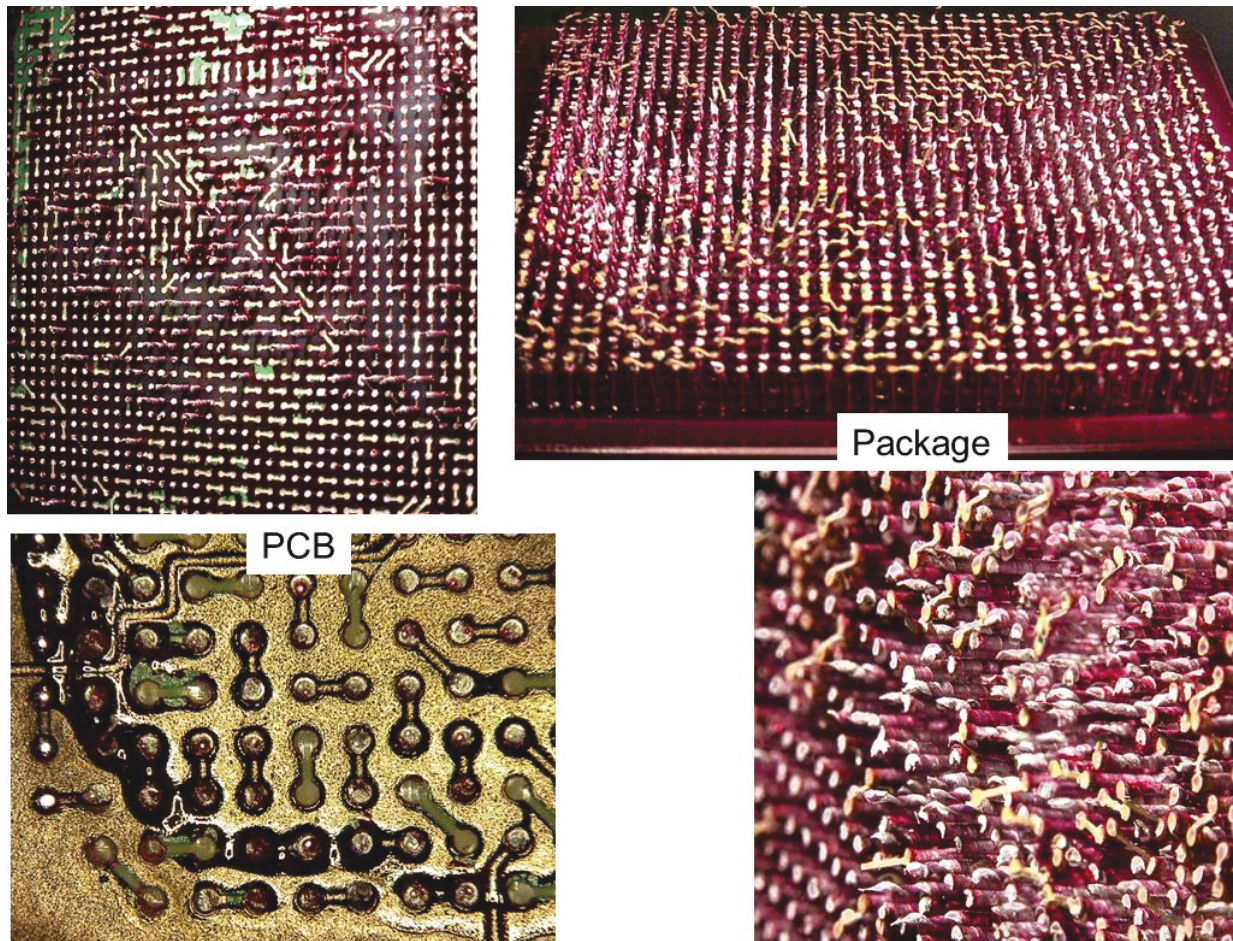
**Figure 4-14.** Representative dye-and-pry photomicrographs of failures at PCB and Package sites for CGA1517 (TV4-023) after cycling ( $-55^{\circ}/125^{\circ}\text{C}$ ).

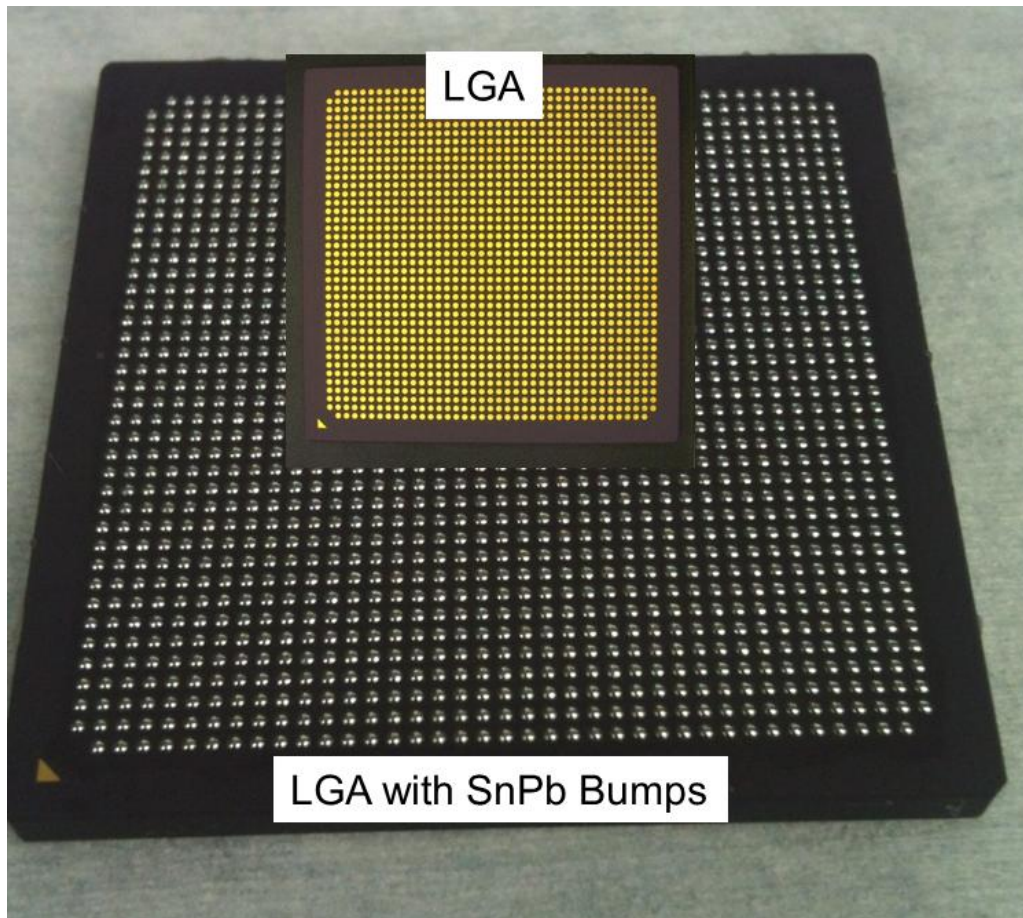
**Figure 5-1.** Ceramic land grid array (LGA) package as received (top) and with solder bumps generated by SnPb paste print and reflow (bottom).

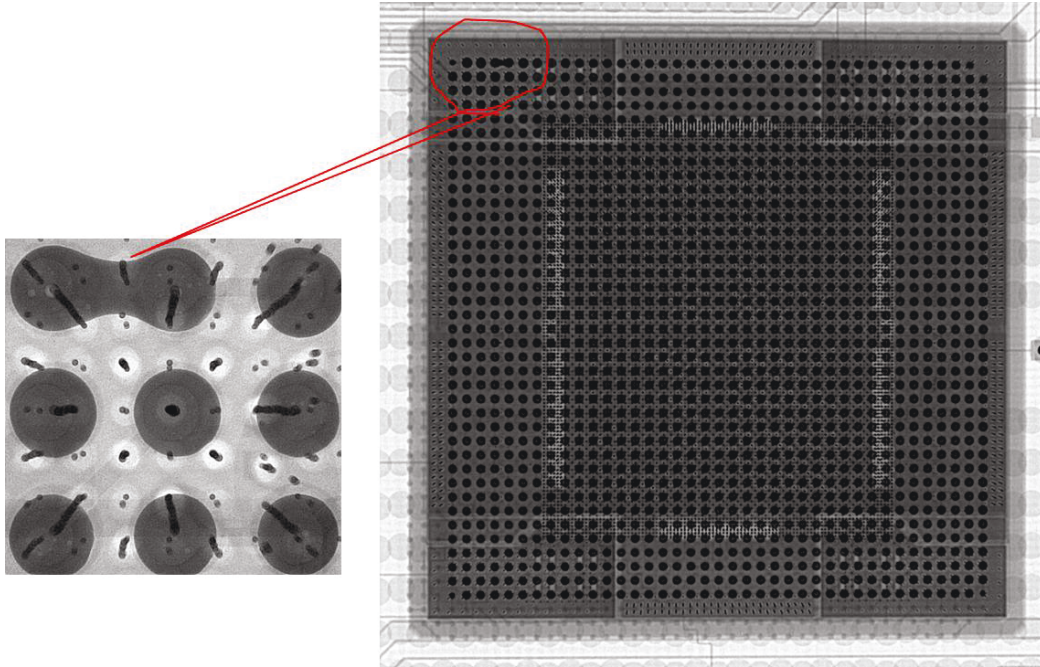
**Figure 5-2.** X-ray photomicrographs of assembled ceramic land grid array (LGA) package showing quality of assembly and expanded view of one solder short.

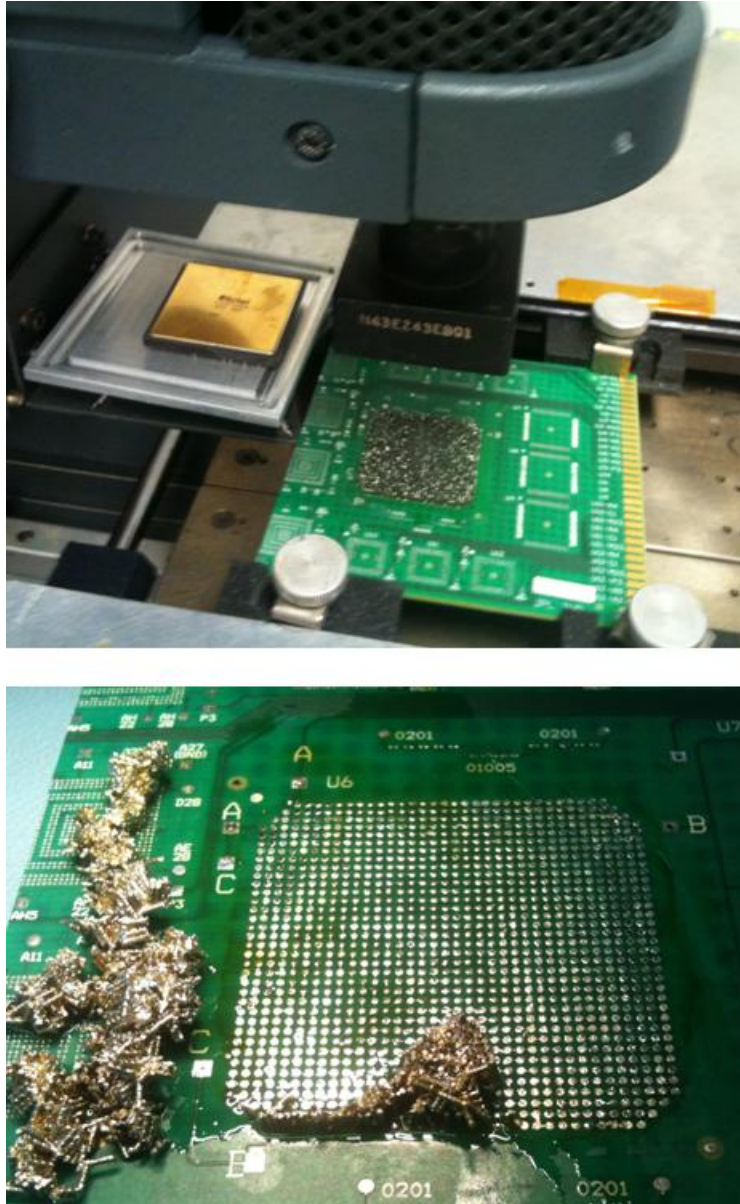
**Figure 5-3.** Photograph showing removal of columns from the pad of PCB (TV5-032) by the rework station in preparation for subsequent assembly of a land grid array version of CGA 1272 I/O package onto a PCB.

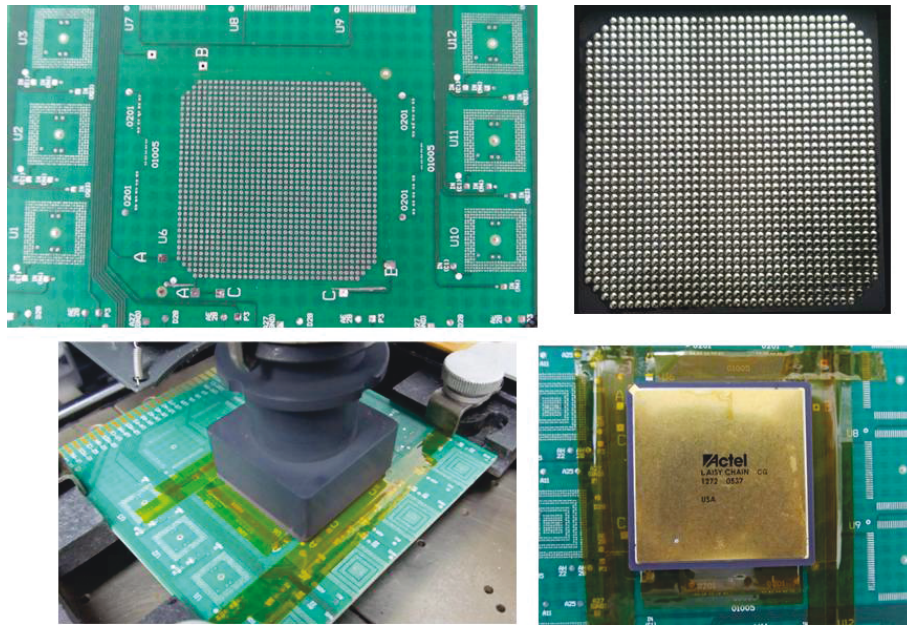
**Figure 5-4.** Series of photographs showing replacement of CGA with LGA 1272 I/O of TV5-032. It shows solder paste print on PCB, solder bumping on LGA1272, Kapton tape stand-off and reflow by nozzle, and final assembly.

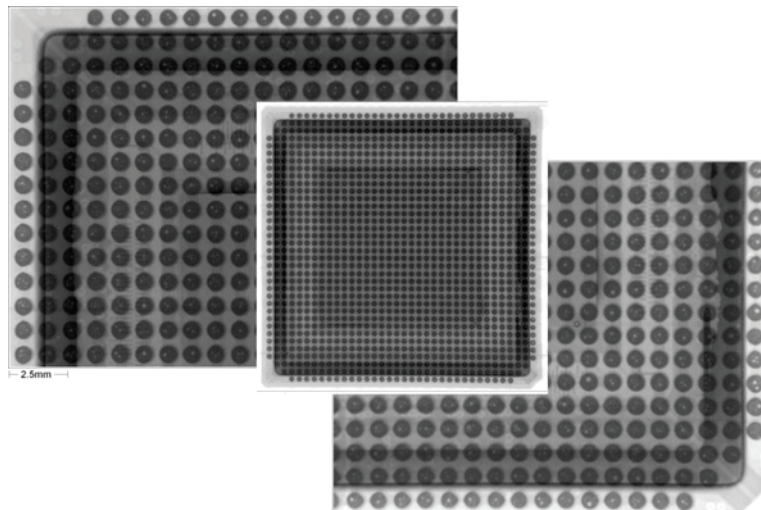
**Figure 5-5.** X-ray photomicrographs of assembled ceramic land grid array (LGA) package (Originally TV-032, CGA) showing no signs of solder shorts.

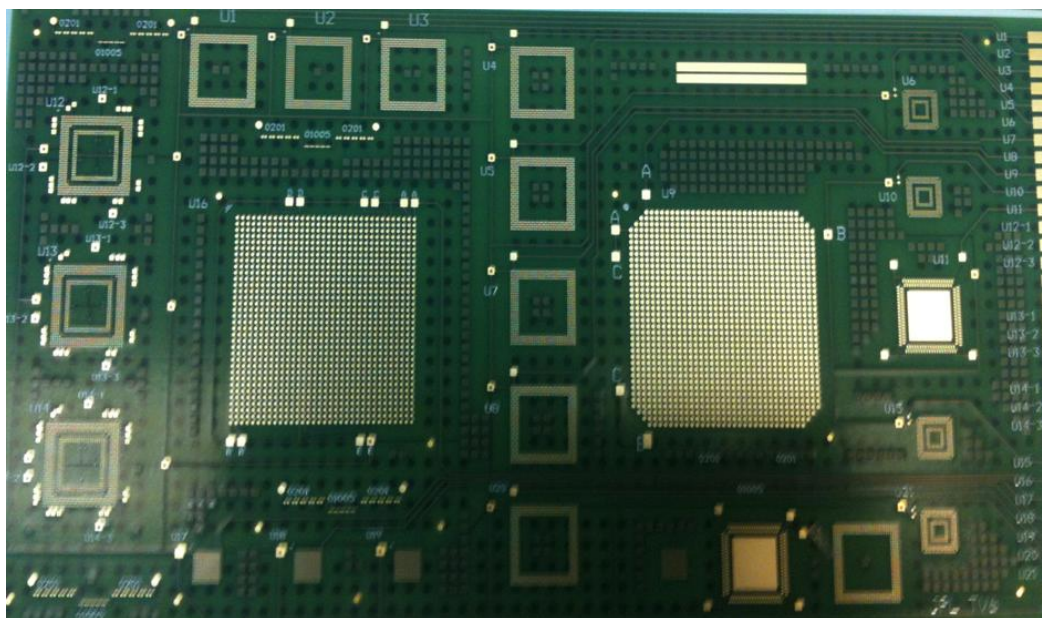
**Figure 5-6.** New printed circuit board test design (TV6) showing patterns for plastic (left) and ceramic (right) high I/Os (1156 and 1272) land grid arrays with a number of other fine pitch pad patterns. The PCB has a number of microvia daisy chains (HDI).

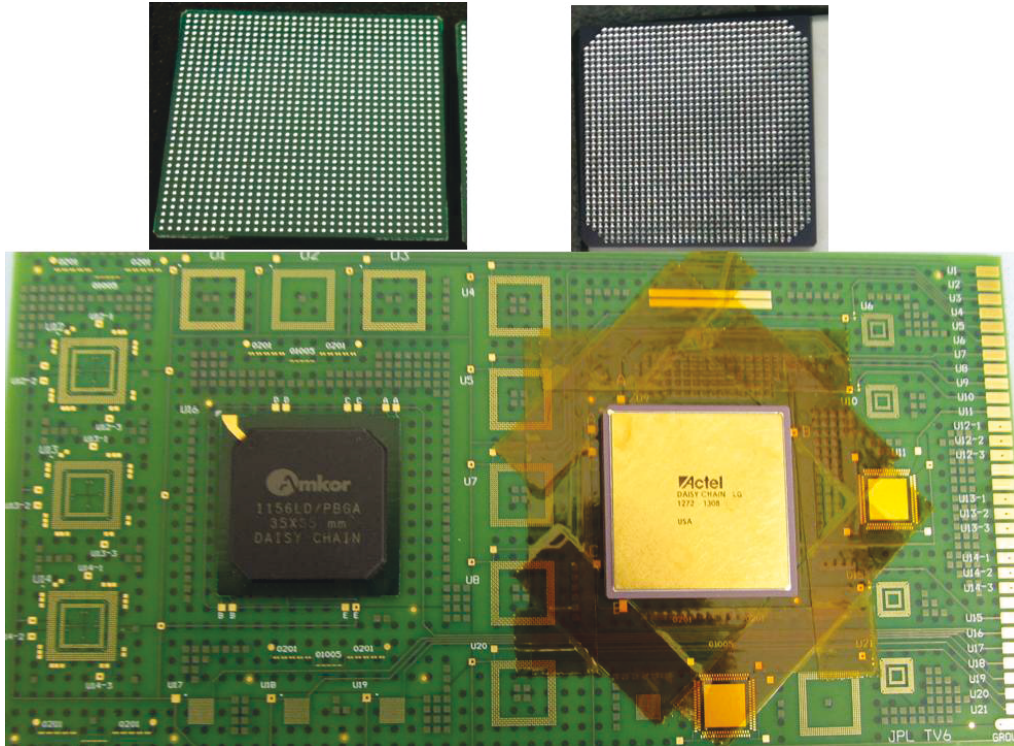
**Figure 5-7.** Photographic images of HDI PCB with plastic and ceramic high I/O packages LGA assembly. Both plastic 1156 I/O (top left) and ceramic 1272 I/O LGAs had solder paste added and reflowed before assembly.

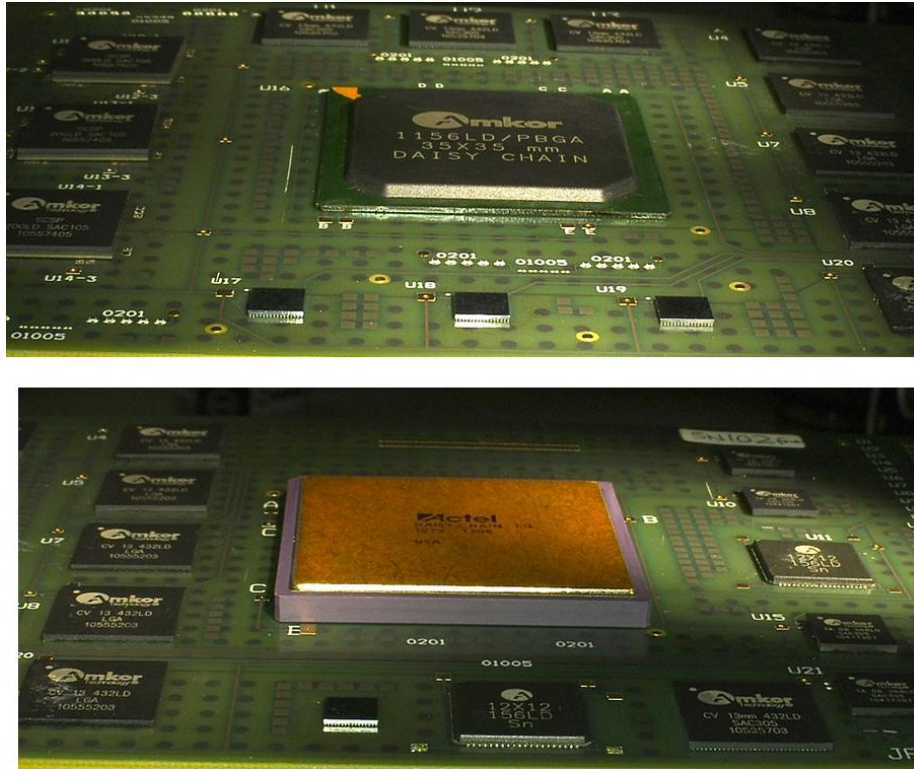
**Figure 5.8.** New test vehicle design (TV6) showing two half images. The top photo shows fine pitch parts surrounding the large plastic LGA 1156 I/O, and the bottom image shows the ceramic LGA 1272 I/O packages surrounded by other fine pitch packages. The PCB has a number of microvia daisy chains (HDI) including large plastic and ceramic LGAs.

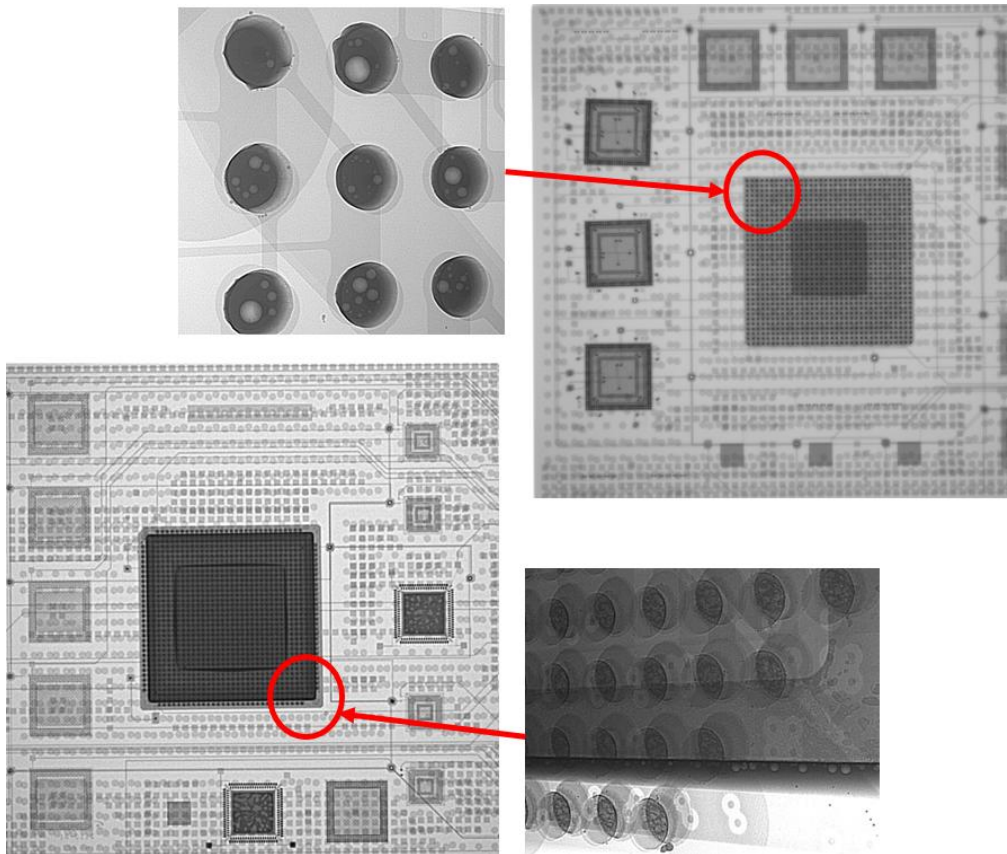
**Figure 5-9.** X-ray photomicrographs of TV6 fully populated assembly. It includes both plastic LGA 1156 I/O (top) and ceramic LGA 1272 I/O (bottom) and X-rays of their corners at higher magnification. Solder joint voids for the plastic LGA and defect anomalies for the ceramic LGA are apparent.

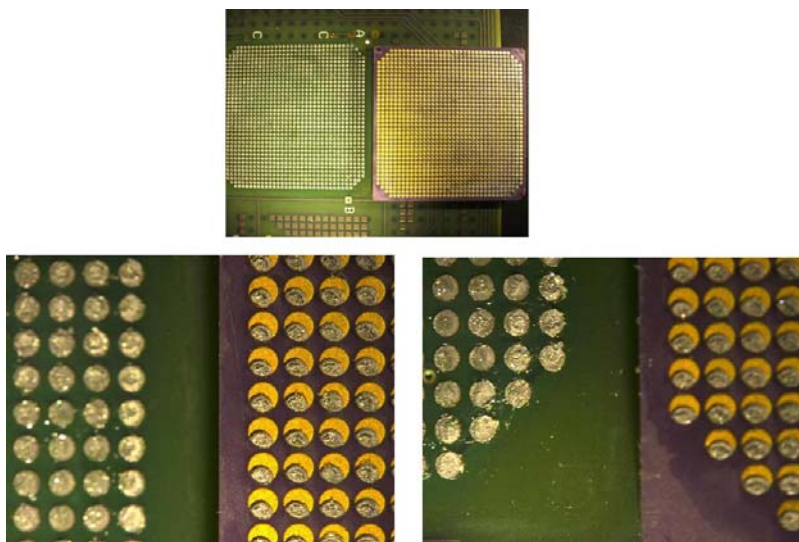
**Figure 5-10.** Optical photomicrograph of a ceramic LGA 1272 I/O showing optically apparent solder joint anomalies confirming the anomalies detected by X-ray.
